GO Number	S/A Number	Page 1 of	Total Pages	Rev. Ltr/Chg. No. See Summary of Chg.	Number
97055	61000	150	151	A	EID-04628
Program Title CLOSURE OF ETEC (R21-RF)					
Document Title FINAL REPORT FOR DECONTAMINATION & DECOMMISSIONING OF FORMER SODIUM DISPOSAL FACILITY (FSDF) - B/4886					
Document Type OPERATIONS (D&D) REPORT			Related Documents		
Original Issue Date 10-5-99		Release Date 11-17-99 <b>RELEASE</b>		Approvals R. D. Meyer	
Prepared By/Date Alex Klein 9/29/99		Dept. 117	Mail/Addr T038	Date S. E. Reeder	
IR&D Program? Yes <input type="checkbox"/> No <input checked="" type="checkbox"/>			M. E. Lee		
If Yes, Enter Authorization No.					
Distribution			Abstract

*	Name	Mail Addr.	This report documents the history and the activities and results of the decontamination and decommissioning of the Former Sodium Disposal Facility (FSDF), also known as B/4886.		
	Marshall, R. A.	T038			
	Lafflam, S. R.	T487			
	Lee, M. E.	T038

This report documents the environmental remediation of the Former Sodium Disposal Facility (FSDF) and its current status. The radiological remediation work is complete, but chemical remediation and site restoration remain to be finished.

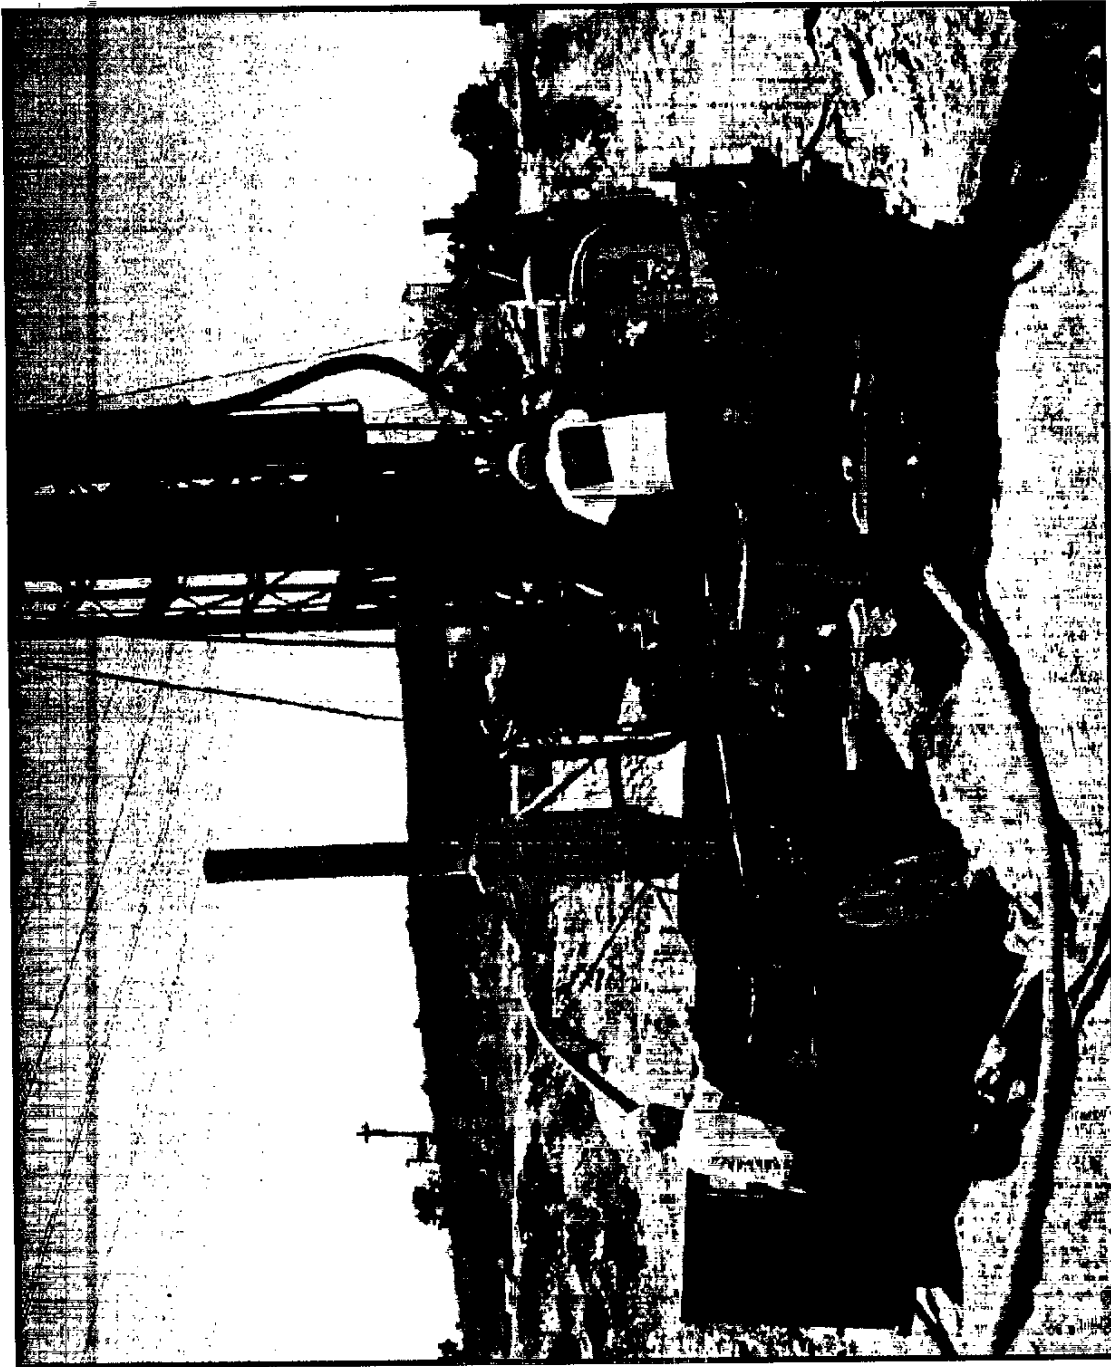
**Figure 32-Drilling well cluster RD-54 in lower pond**

On April 15, 1994 a hydrogeological conditions report for the site was issued (Reference 70, which included information about the 4 wells that were newly installed (RS54 and RD 54abc) and summarized the data characterizing the groundwater following site remediation. See the tasks and results section of the report for the findings.

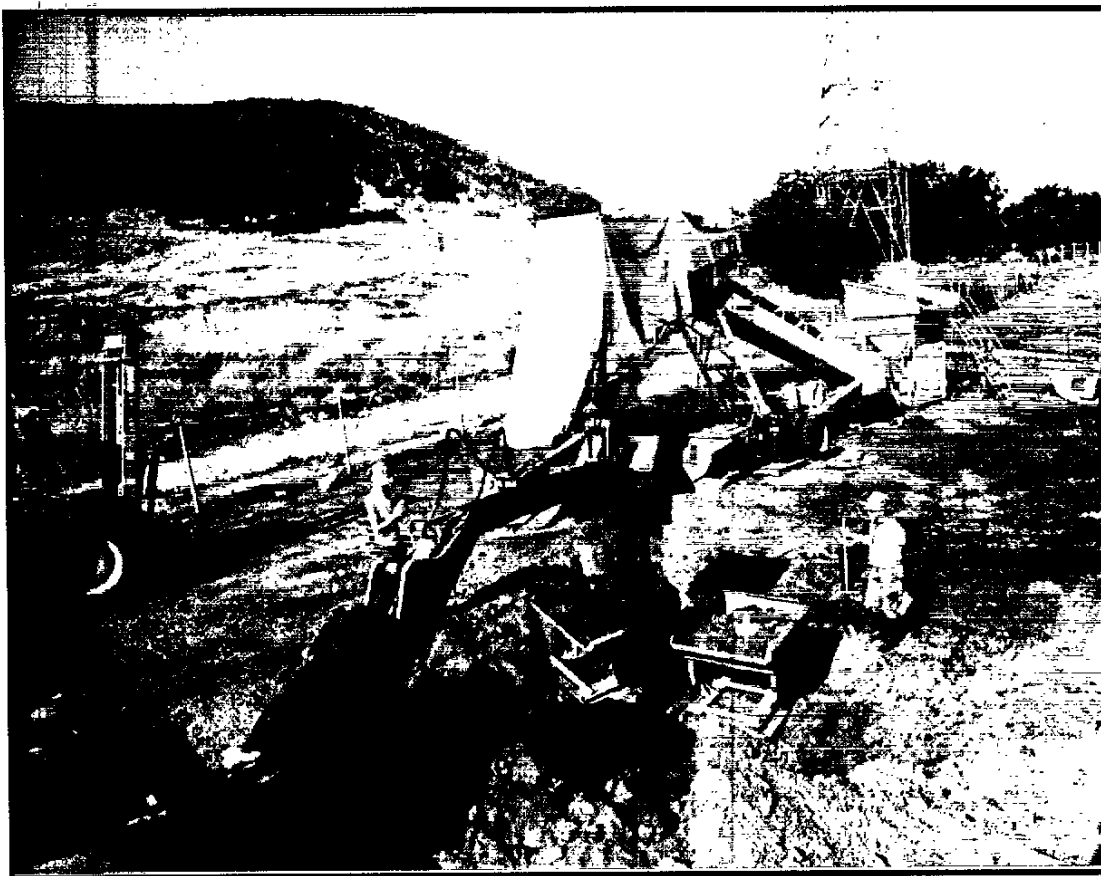
**Figure 33-Sorting and segregating non-hazardous soils**

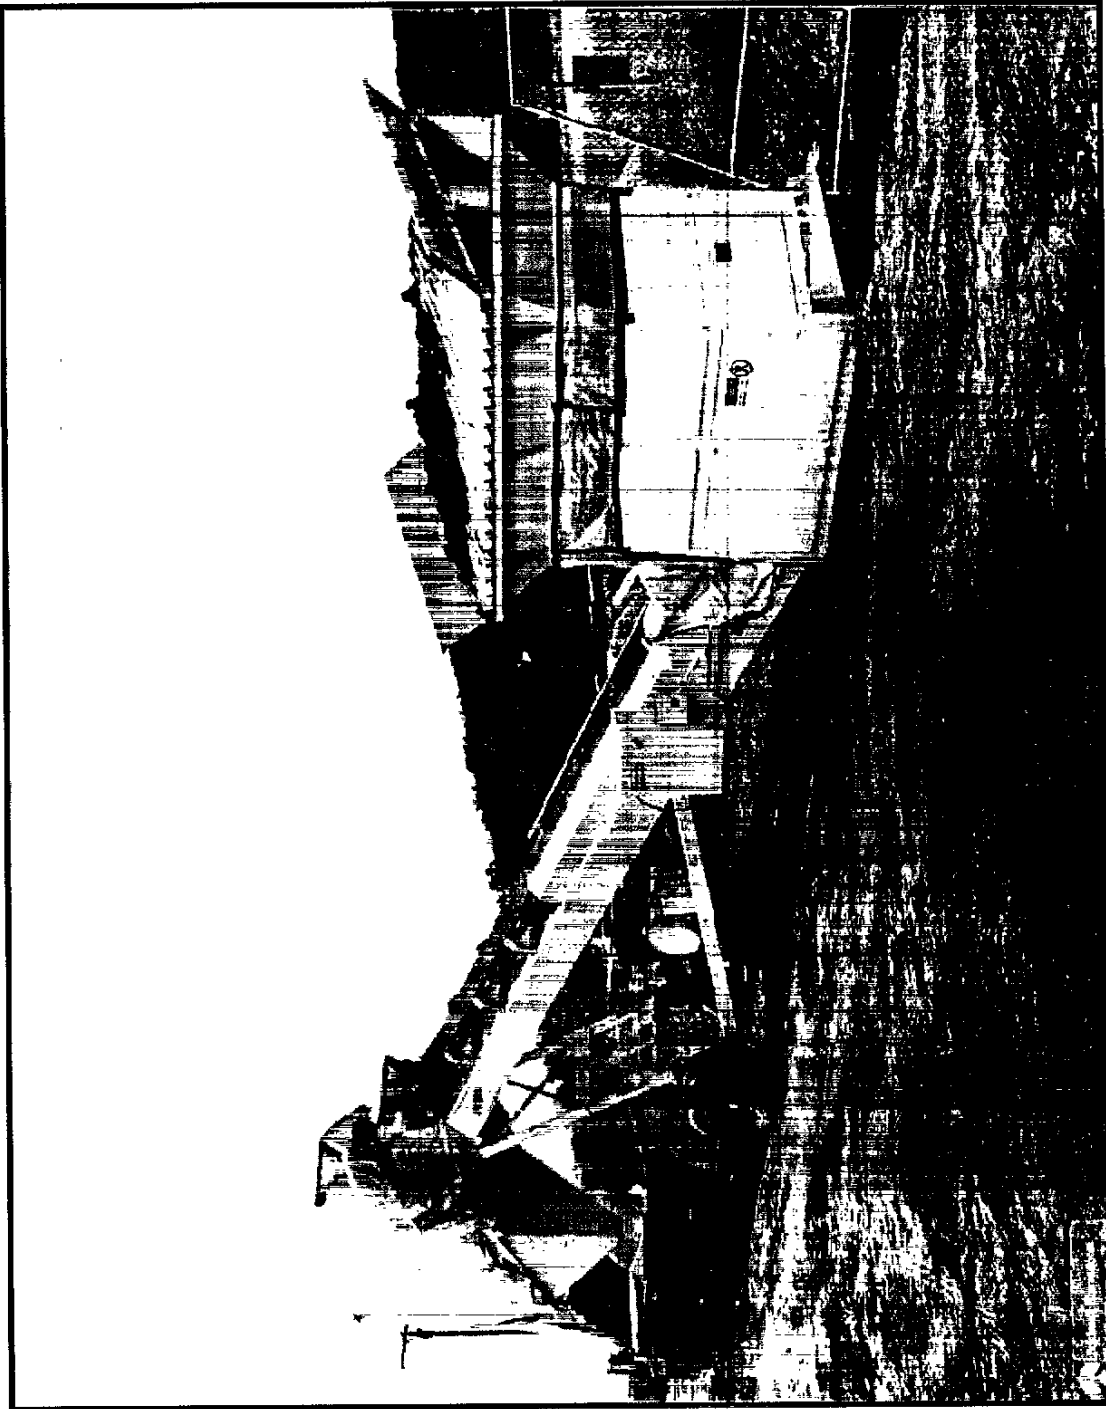
**Figure 34-Soil sorting and handling machine**

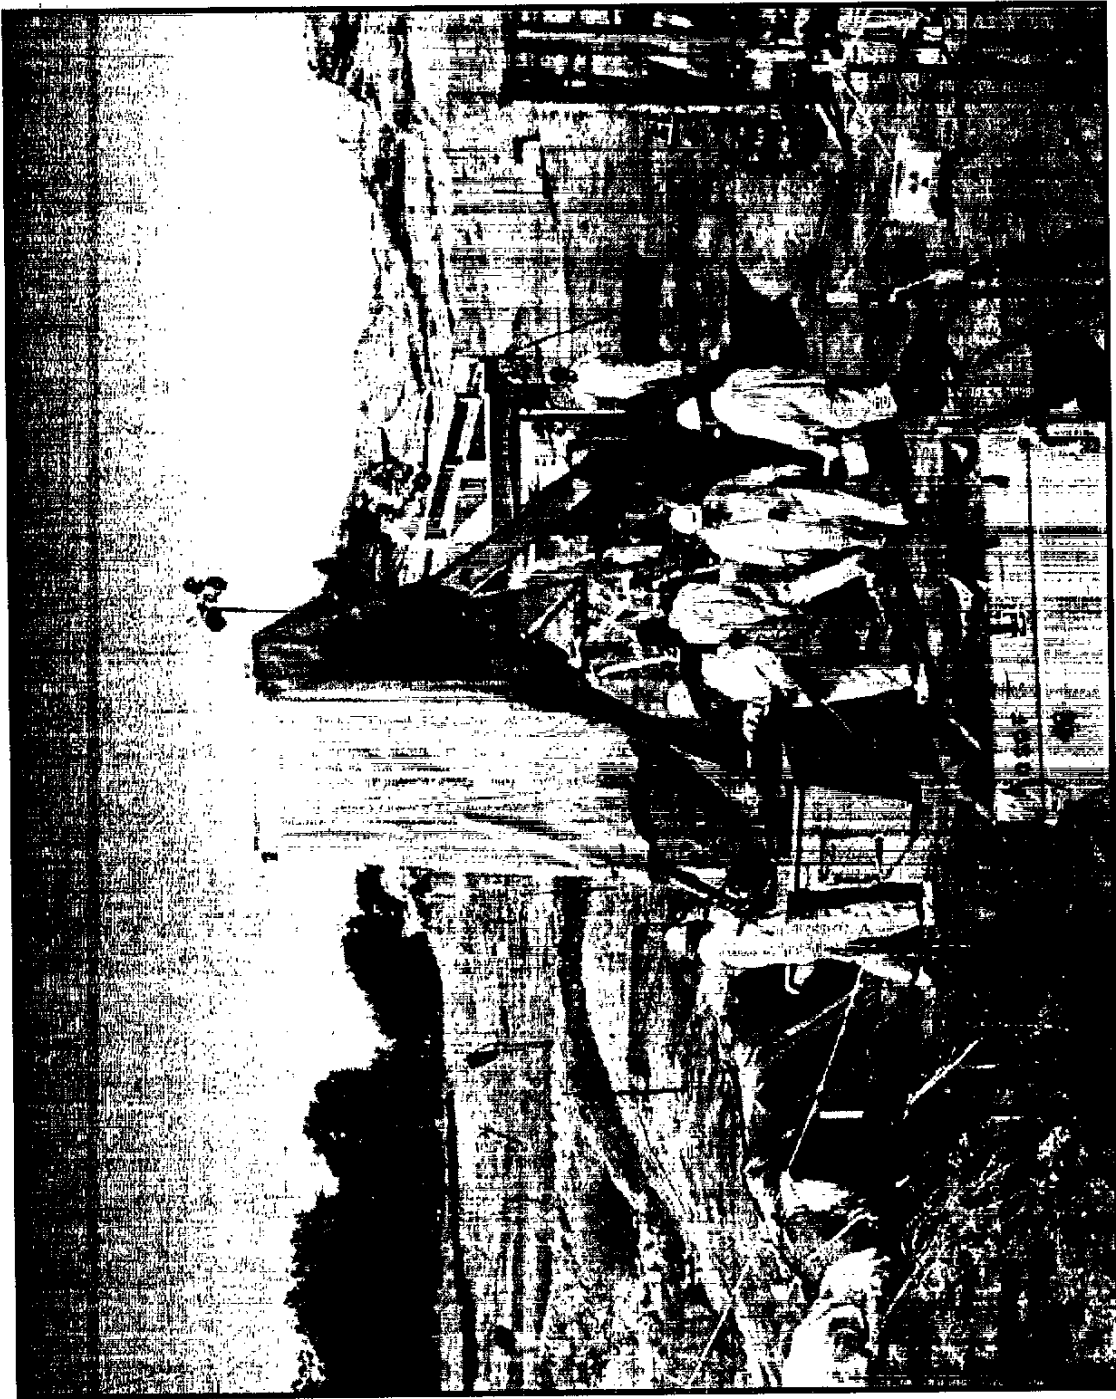
Figure 35-Soil segregation in process

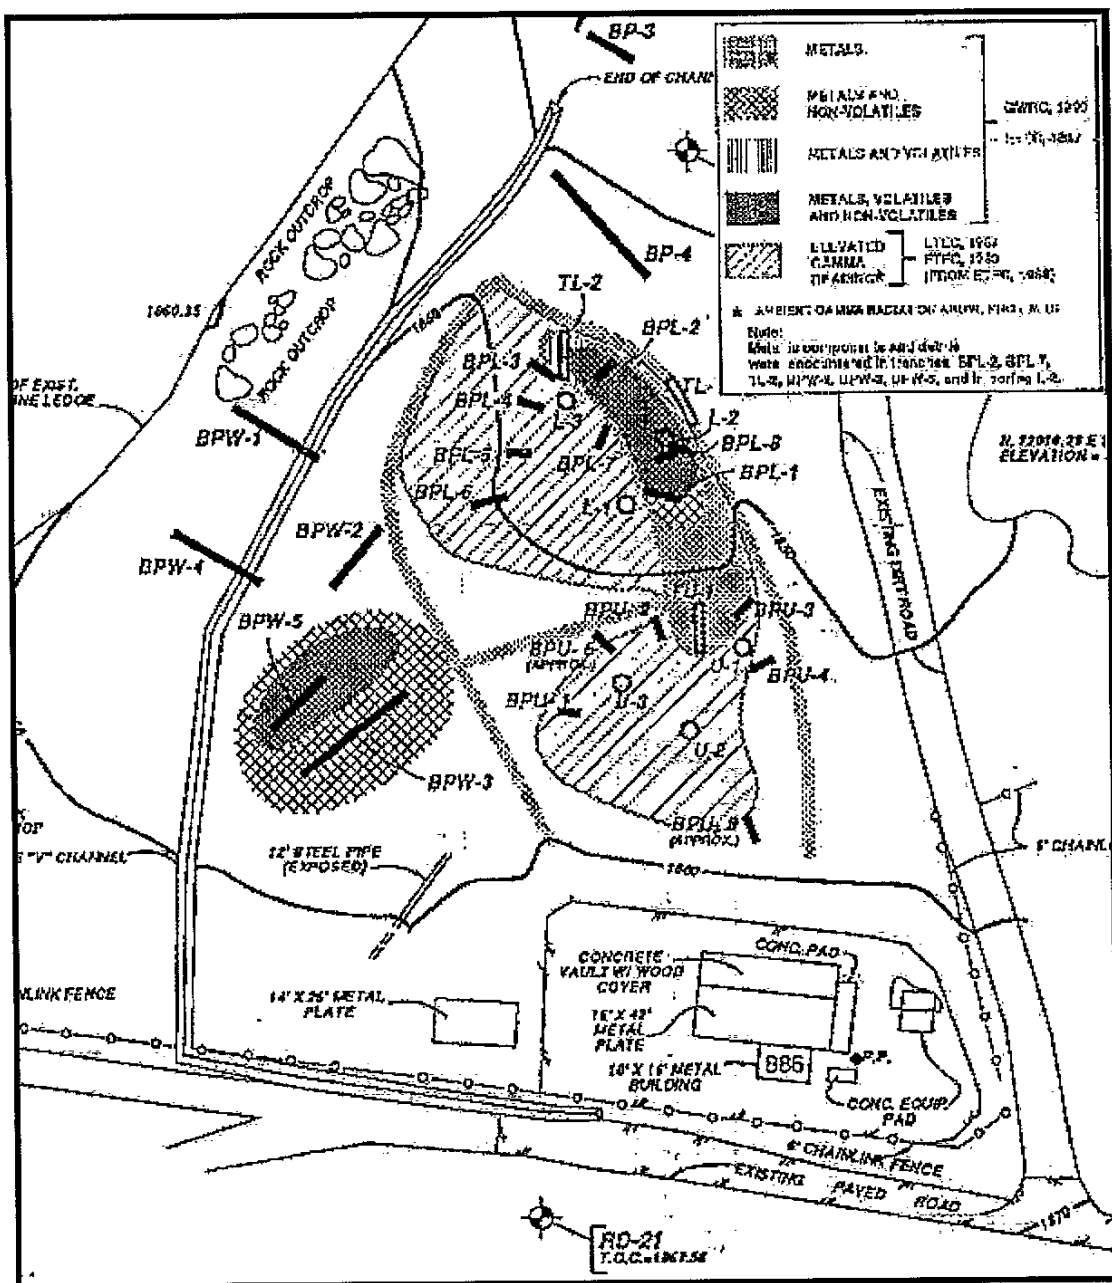
**Figure 36-Composite view of contamination types**

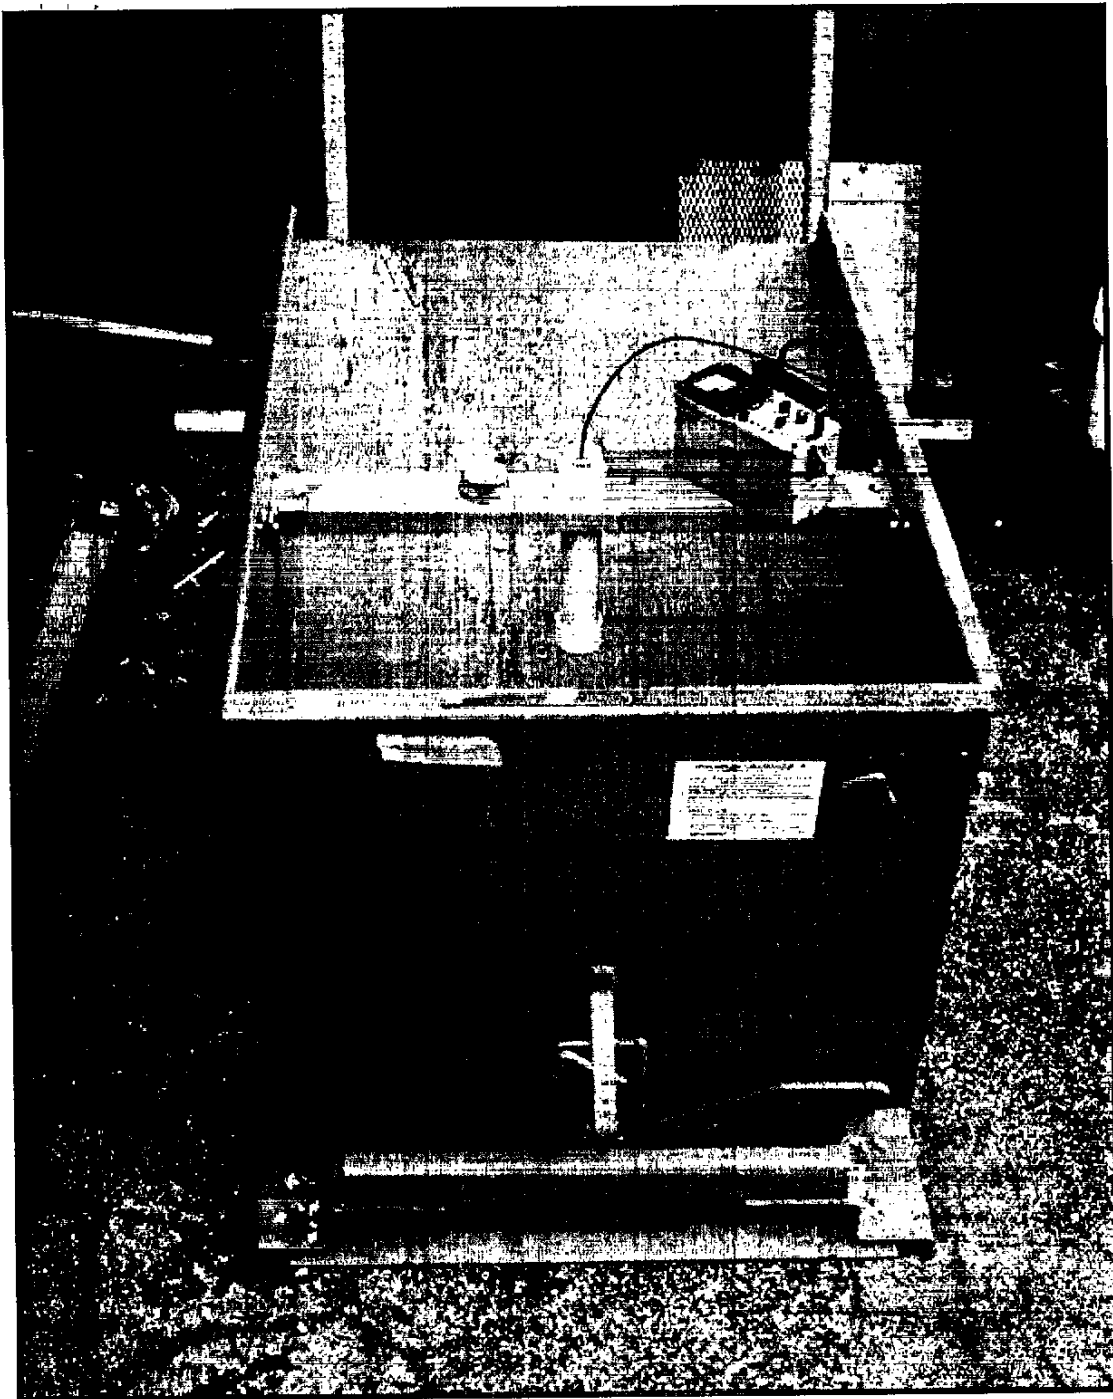
Figure 38-ITC with NaI probe receptacle

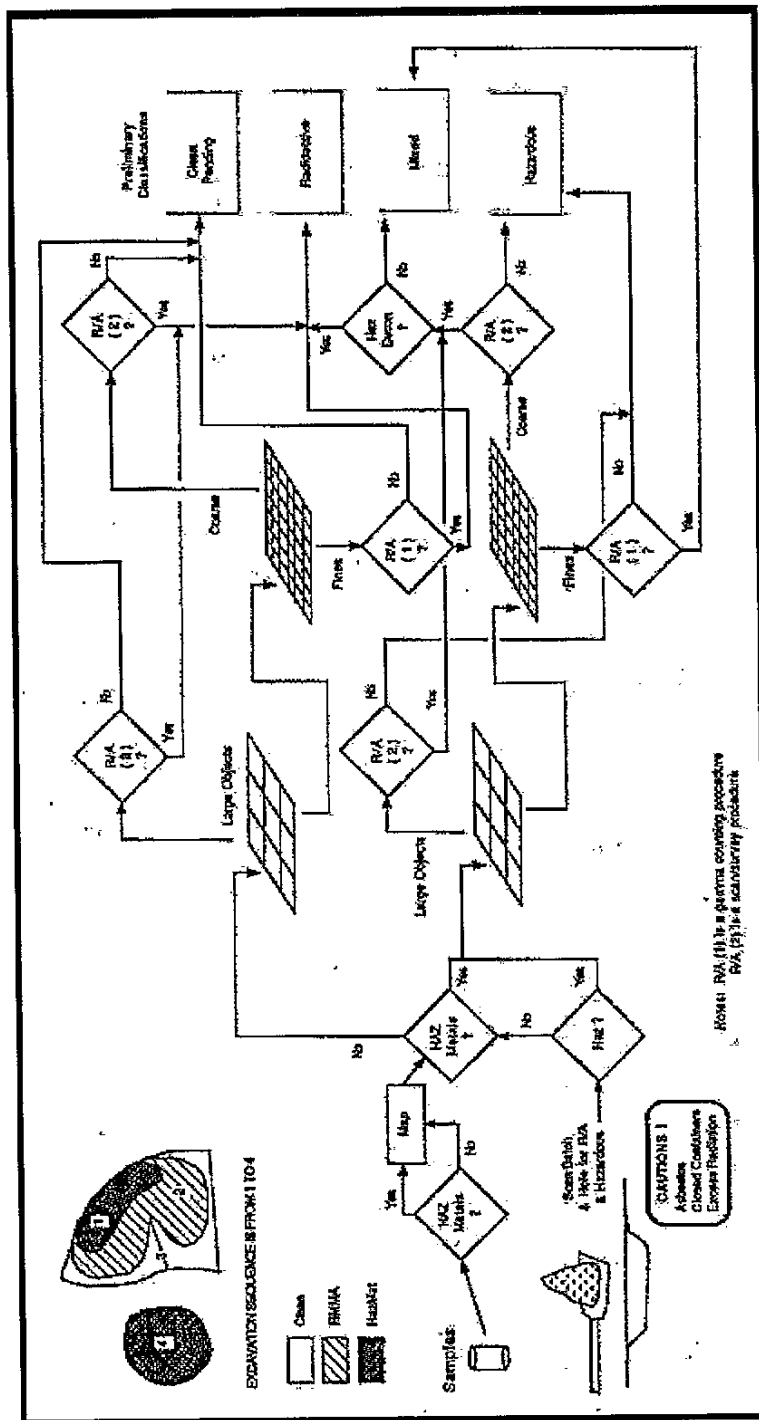
**Figure 39-Excavation, segregation and classification process**

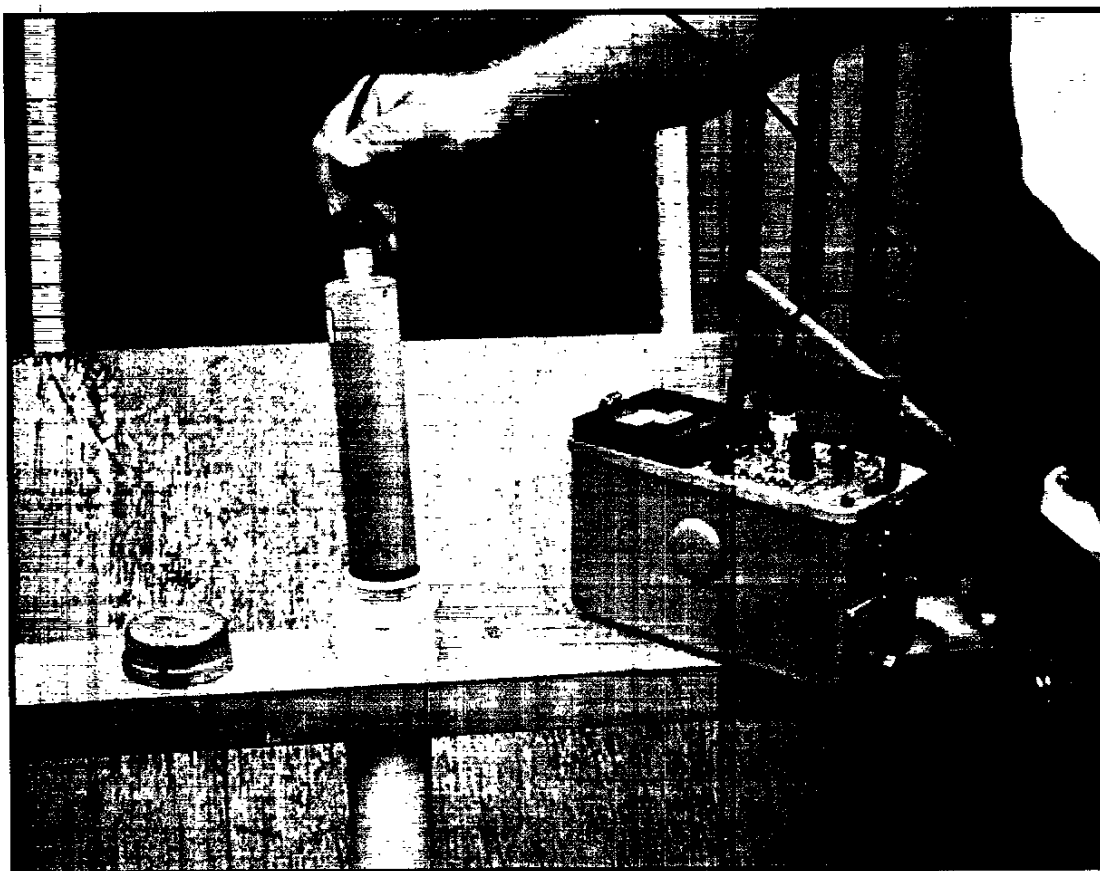
**Figure 40-NaI probe insertion into receptacle**

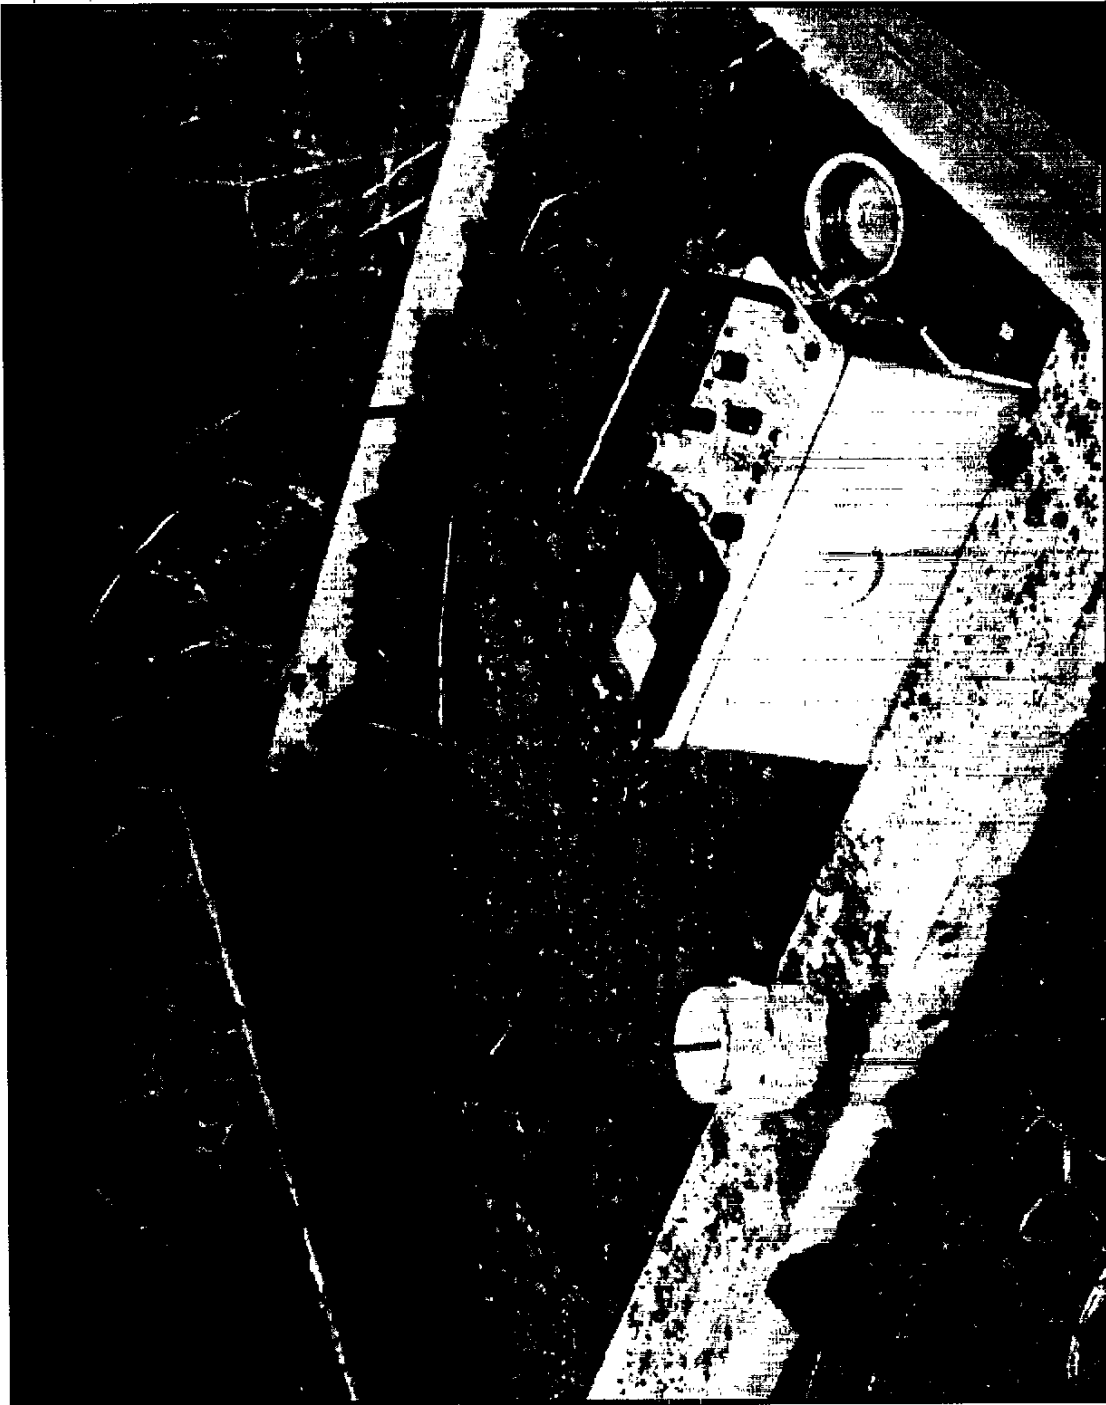
**Figure 41-ITC filled with soil being counted for radioactivity**

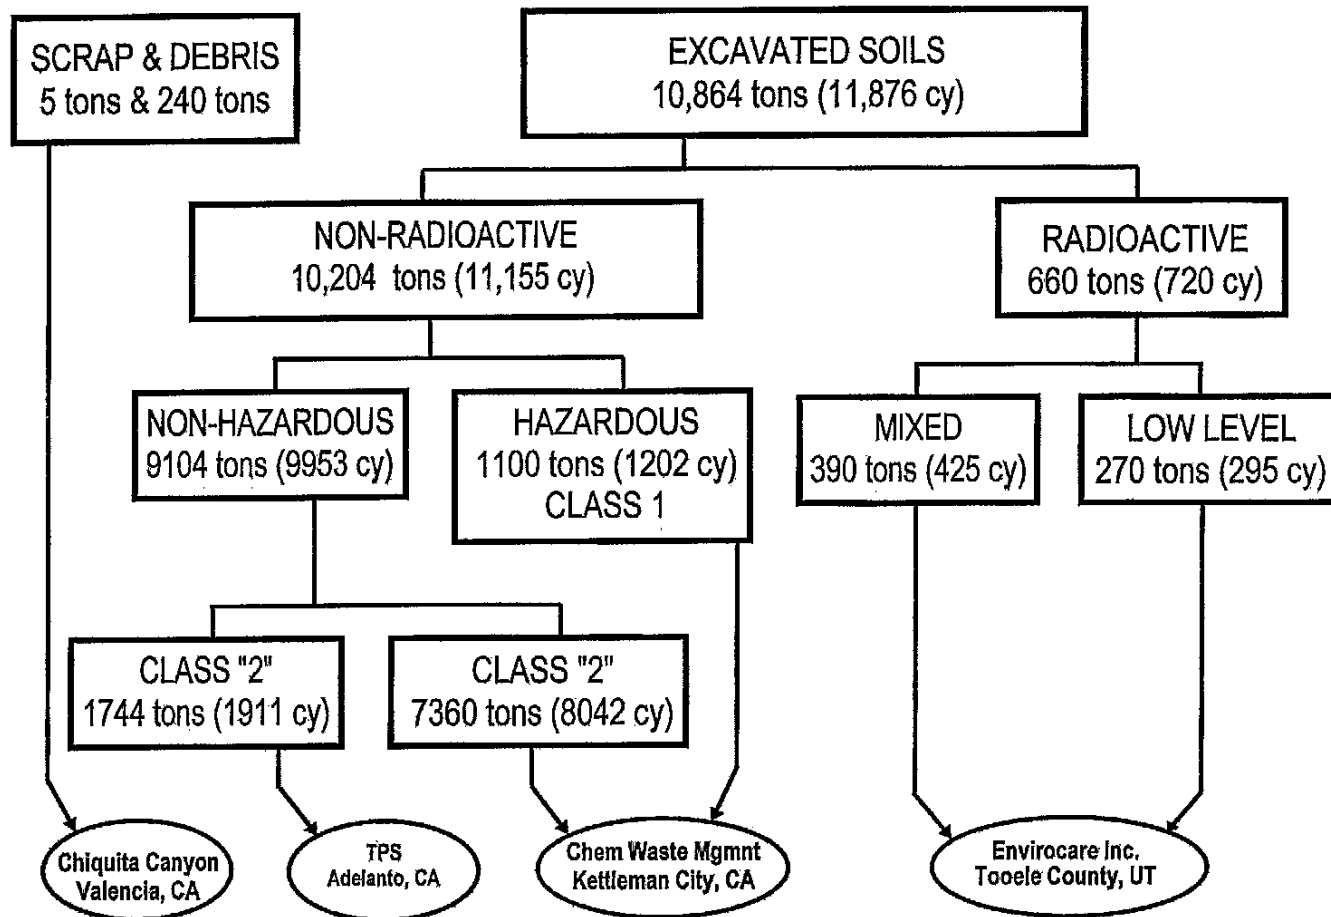
Figure 42-Solid waste streams
